*NIST Special Publication 862*

# 1994 Northridge Earthquake

## Performance of Structures, Lifelines, and Fire Protection Systems

*Diana Todd, Nicholas Carino, Riley M. Chung, H. S. Lew, Andrew W. Taylor,  
William D. Walton, James D. Cooper, and Roland Nimis*

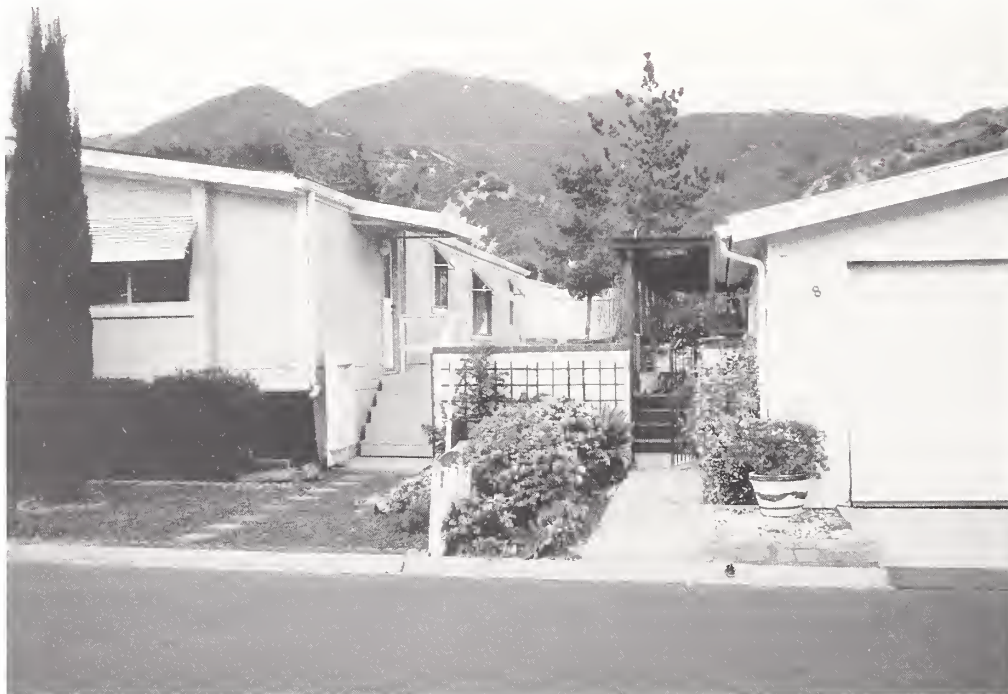
Building-to-building fire spread was limited to three manufactured housing developments (mobile home parks). Figure 6.8 shows the typical spacing between units in one of these developments. Figure 6.9 shows an area of the development destroyed by fire. Observations made at this development indicate that the method of unit-to-unit fire spread was primarily through windows. Once a unit became completely involved in fire, the thermal radiation was sufficient to cause the breakage of windows in an adjacent unit or to ignite combustibles within the unit directly through the windows. The fire department reported low water pressure in the area which combined with multiple independent fires and limited resources hindered fire fighting operations. The fire spread was stopped either by separation such as roads and open areas or by fire fighting operations.

Figure 6.8. Typical unit spacing in a manufactured housing development.

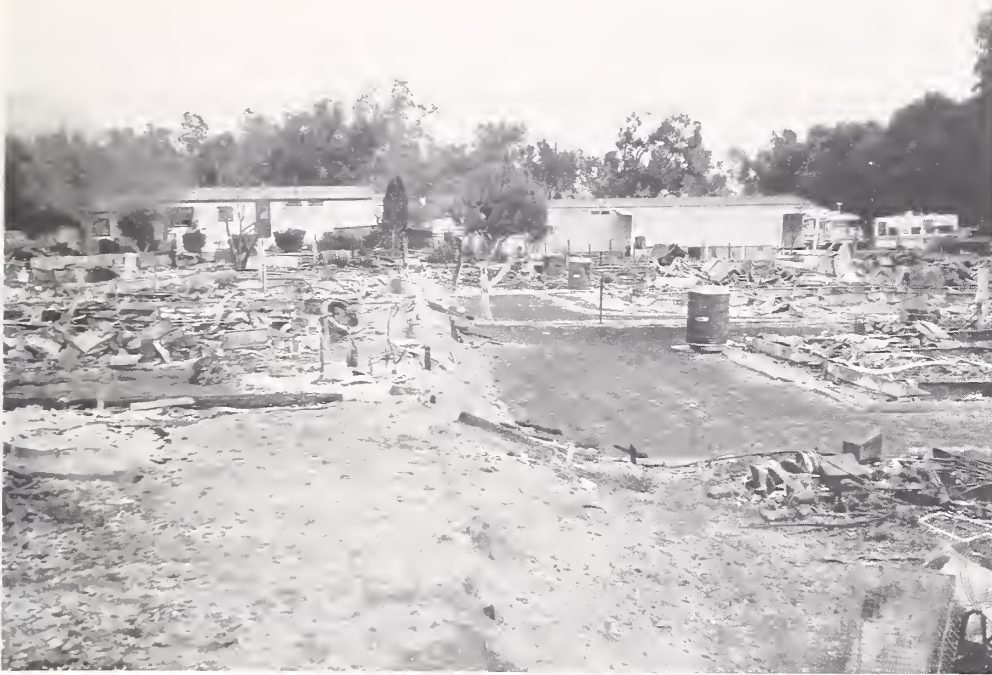
Figure 6.9. Impact of a multiple unit fire in a manufactured housing development.

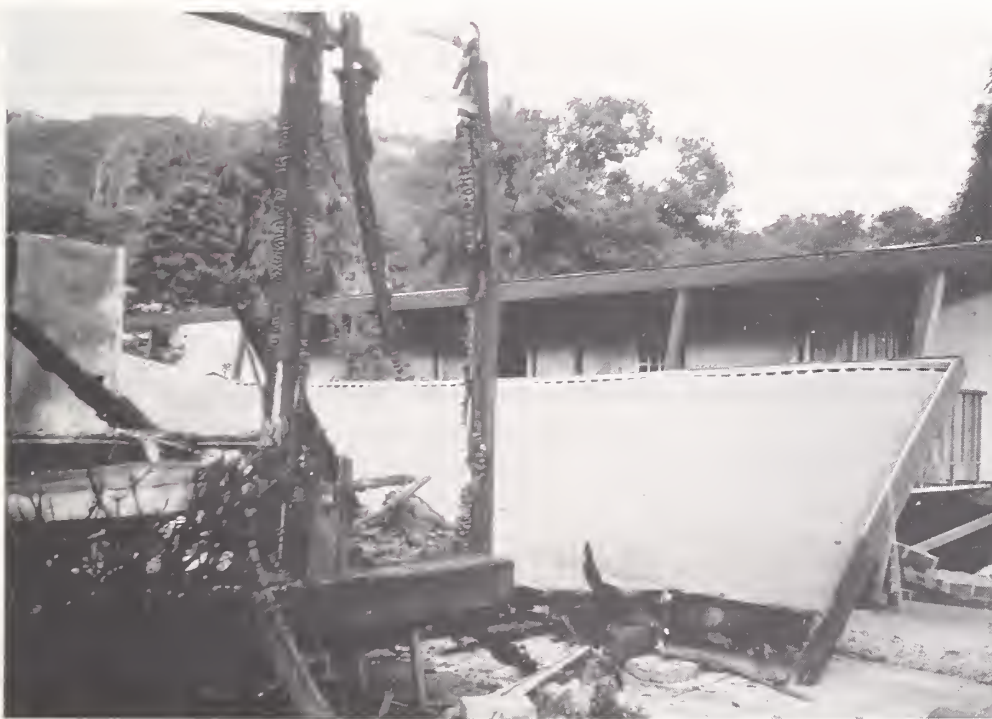
A unique aspect of the construction of these manufactured units played a role in limiting fire spread and assisting fire department actions. As the units burned from the inside, the carport roofs collapsed from the building side, coming to rest on the outside supporting columns. In this way the carport roofs formed fire breaks as shown in figure 6.10. Although these roofs would not necessarily have survived the fire by themselves, they reduced the fire exposure on adjacent units and thus enhanced fire fighting operations.

Figure 6.10. Collapsed roof which acted as a fire break in a manufactured housing development.
